## Grange House, Wyvern Sculptures

### Introduction:

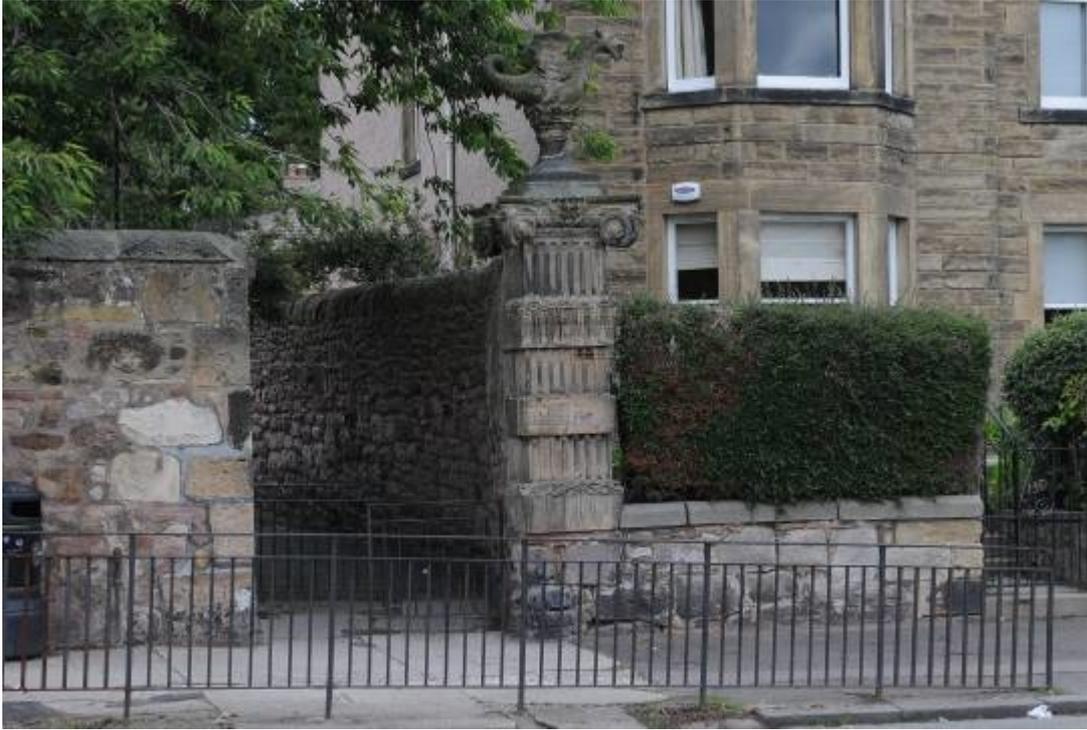
The westerly sculpture has a fracture through the tail which appears stable and is probably a repair to previous damage. The pedestal below the crown decoration displays an old fracture which has been repaired and pointed in the past – this damage may be associated with oxide jacking caused by an internal ferrous dowel. Under the lower jaw of the wyvern is a small daub of blue paint. The surface of the sculpture is colonised by a thin layer of green biofilm growth no doubt encouraged by an overhanging cherry tree. Localised areas of black pollution products are evident however these deposits are relatively light and whilst this could be regarded as visually detrimental it does not impact greatly on the performance or condition of the stone.

The carving of the ionic capital remains clearly legible however there is evidence of deterioration in the form of disaggregation of the sandstone along its natural sedimentary bedding. One of the volutes facing the street is damaged where a large fragment has broken off although this may be old damage?

The fluted pillar stones below are suffering from superficial and localised areas of granular disaggregation but this will not impact greatly on the stones longevity as a structural element. The whole pillar has a slight lean to the west and there is evidence of movement where it abuts the adjoining wall as the joints of the masonry have opened.

Westerly wyvern and supporting pillar

- Re-pointing of bedding joints in the column and the wall where necessary using a lime mortar.
- Applying a survey ‘tell-tale’ to monitor any further movement in the westerly pier or monitoring the re-pointed wall for newly formed fractures.

- Some local consolidation of disaggregating stone may be considered particularly on the capital stone of the westerly pillar.
- Treatment to remove the identified graffiti and the paint splash should be considered but only if this can be achieved without further damage of the stone.

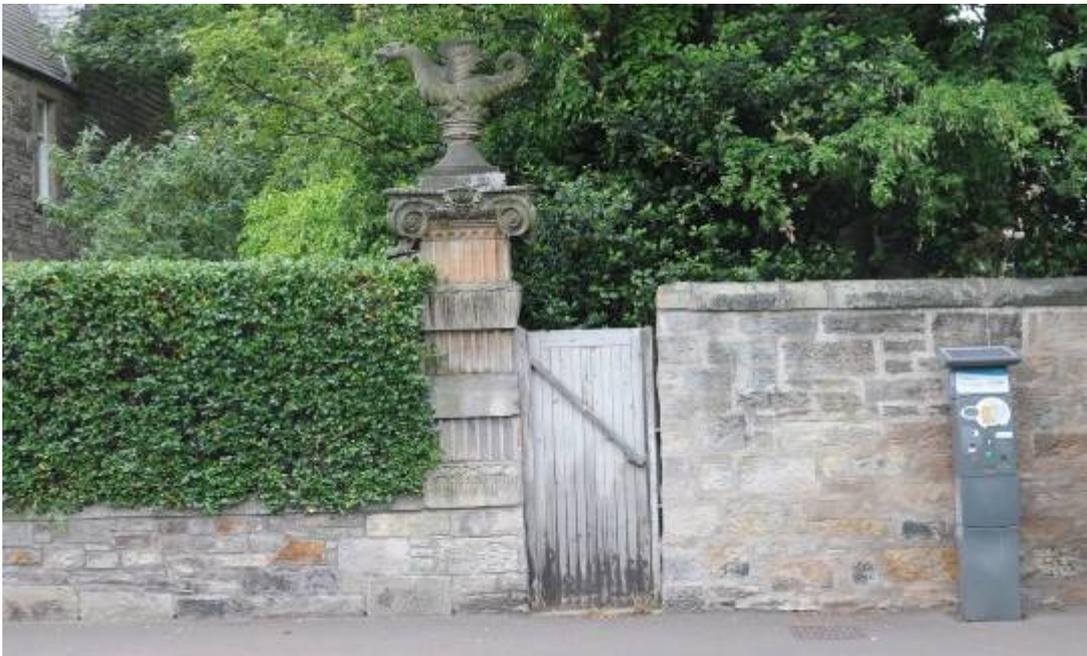
The easterly sculpture is in a similar condition however other than the obvious losses to the carving it is free of fracturing. The pedestal below the crown decoration displays an old

fracture that has been previously repaired and pointed – this damage may be associated with oxide jacking caused by an internal ferrous dowel. The surface of the wyvern and the capital are colonised by a thin layer of green biofilm growth promoted by the overhanging tree branches. Light deposits of atmospheric pollution soiling are evident particularly on the wyvern and the capital but of minor consequence in terms of the preservation of the carving. The capital is in good order with only minor areas of disaggregation most evident on the fluted decoration where the natural bedding structure is exposed. The fluted pillar stones below are suffering from localised areas of granular disaggregation but this loss is fairly superficial and not of any concern. Some ‘ghosting’ of previously applied graffiti is apparent on one of the lower stones of the pillar.

Easterly wyvern and supporting pillar

- Hand cleaning using only water and a medium nylon or natural bristle brush to remove the growth and superficial soiling.
- Re-pointing of fractures on the wyvern and pedestal using a colour matched acrylic mortar.

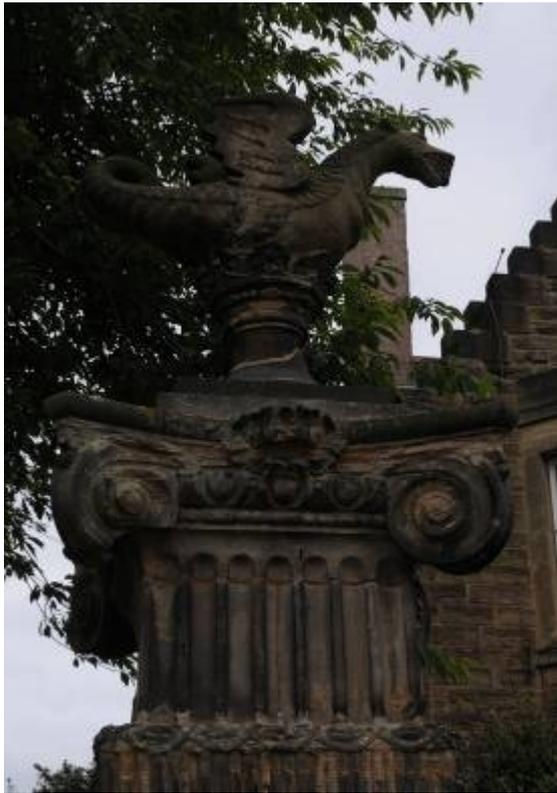
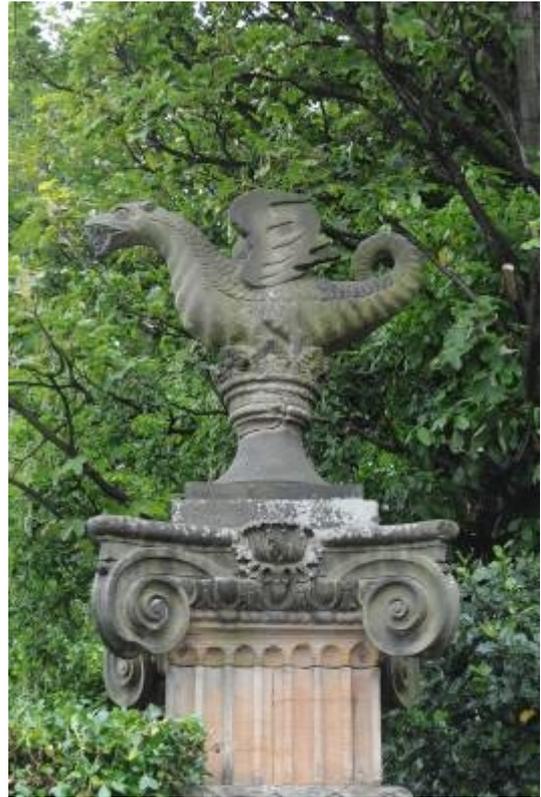
The general condition of both wyvern sculptures is good and the carving remains well defined and stable. In both cases there is evidence of loss including the wing tips, tail end, ears, tongue and details of the crown. This damage does not appear recent and may well have occurred when they were moved from their original position.

General views of the wyverns

- Replacing the missing carved elements such as the wing, tail and ear tips as small stone indents scribed to the broken face.
- Laser cleaning to remove the black pollution soiling..
- If ongoing movement is detected in the westerly pillar it may be necessary to dismantle and rebuild to avoid possible future collapse.

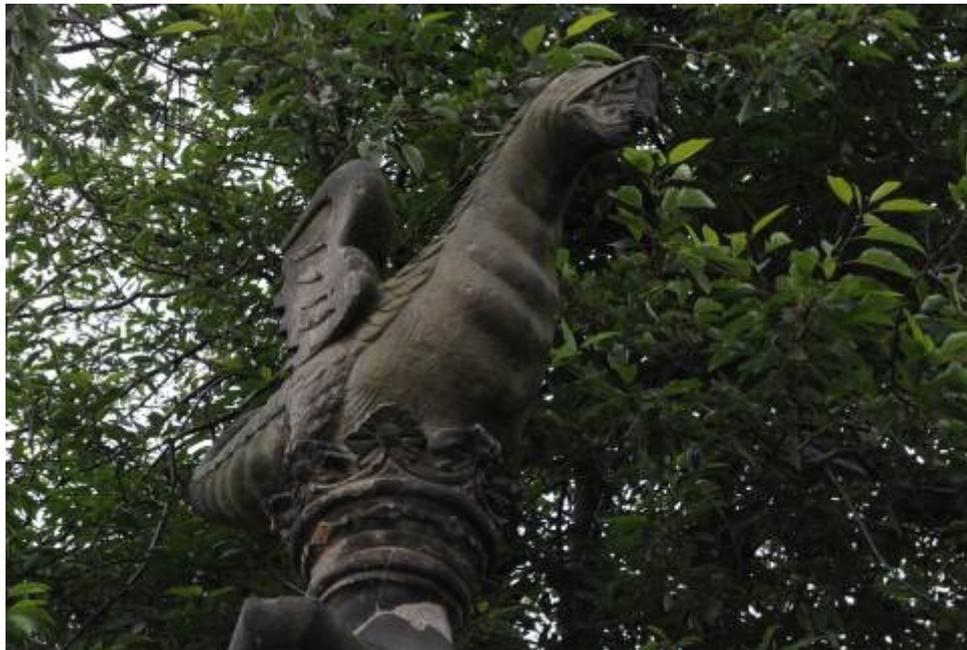
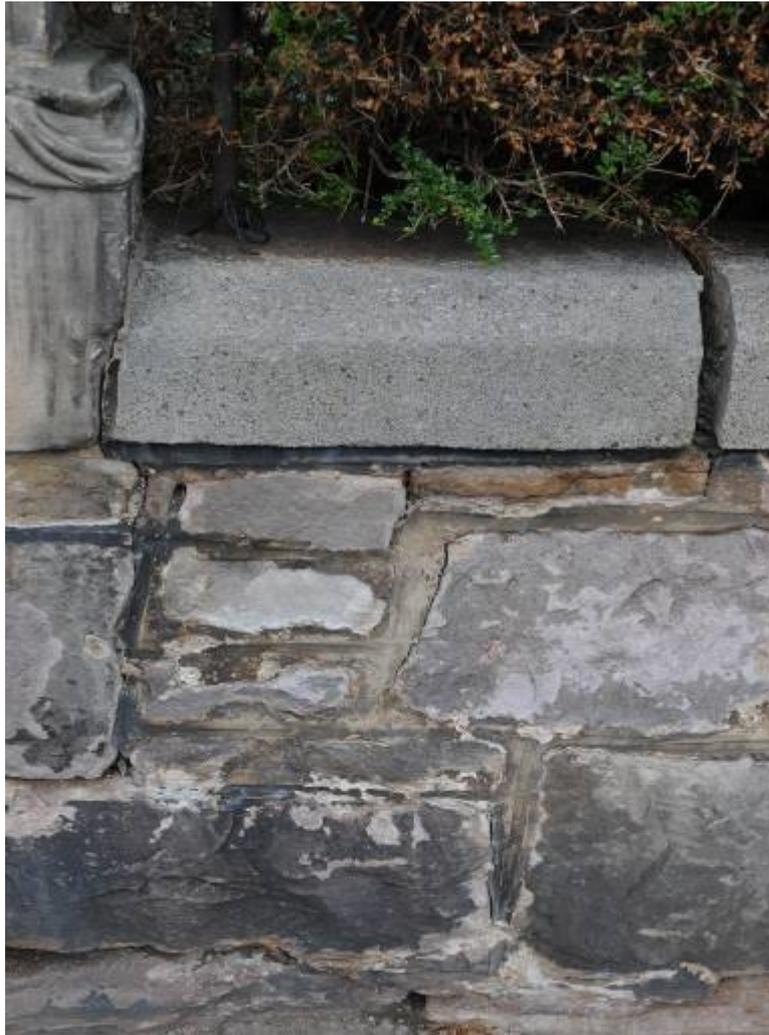
Evidence of movement at the base of the westerly pier
