# Grange Cemetery

## Restoration of Monuments

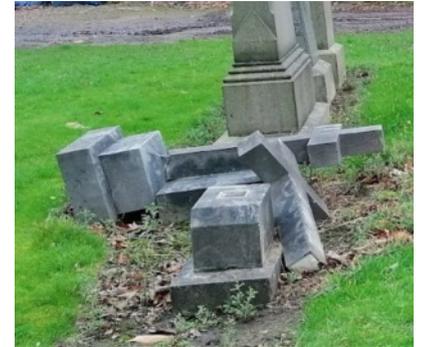
Serious injuries and fatalities caused by falling headstones in cemeteries in the UK over many years led to a Health & Safety Executive requirement that local authorities must survey all monuments in cemeteries. Any monuments deemed unsafe had to be laid flat. As a result, by 2006, nearly 9,500 dangerously unstable headstones were laid flat in Edinburgh cemeteries. Although Grange Cemetery was in better condition than most, many stones had to be laid flat. Other stones had already fallen, leaving some areas of the cemetery looking very messy.

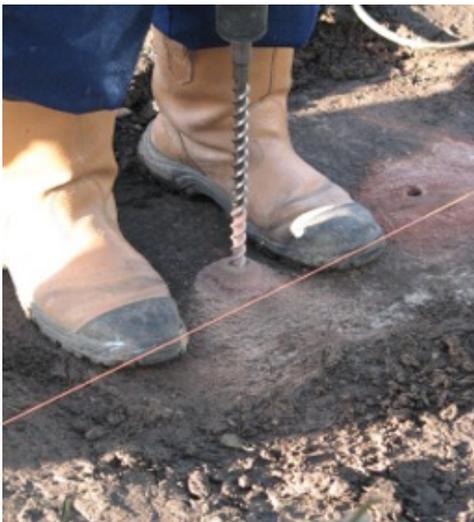
*Drilling poured concrete foundation*

The work takes time. It begins with laying aside the monument, lifting any base stone and then removing the original brick foundations, some deeper than others. Concrete is then poured in to form a new base. This has to be left to cure for 14 days before inserting stainless steel rods into drilled holes and returning the monument to its vertical position. The weather can delay progress because the concrete has to be poured in frost-free conditions. Restoration of some stones takes longer and is more costly than others depending on the size of the stone and thus the depth of the foundations and the length and thickness of the steel pins.

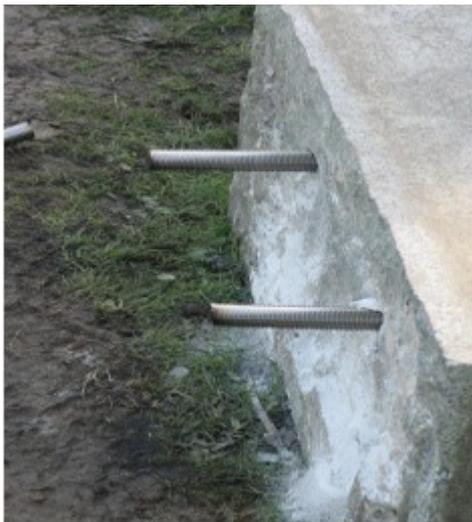
*Foundation stone drilled with stainless steel rods inserted*

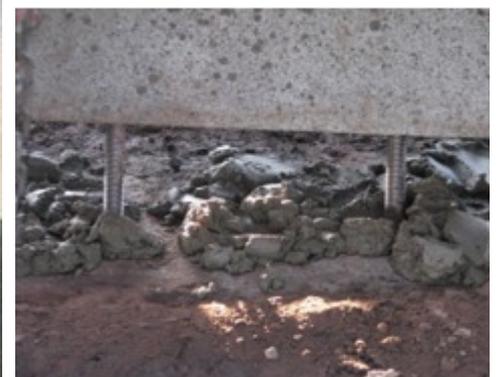
*Steel rods offered to drilled foundation on a bed of soft stabilising cement*

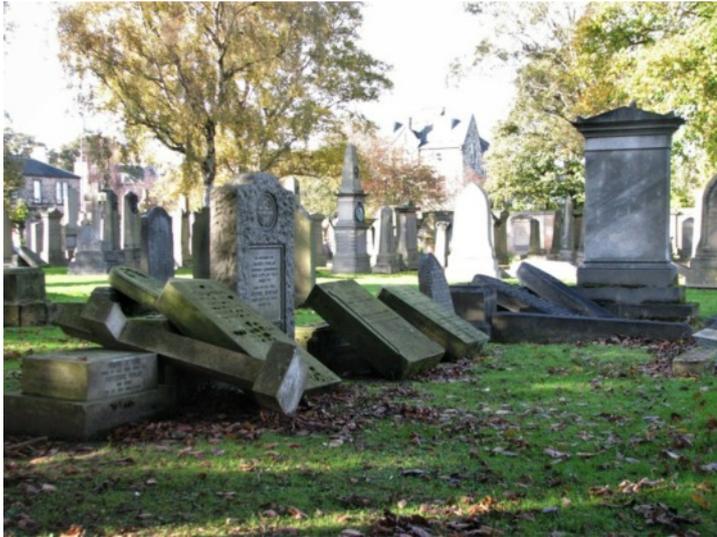
**BEFORE**

*The stones above have been restored by Community Payback Order workers. They can be found in the block to the north east of the main path to the tunnel at the catacombs, to the east of the group below.*

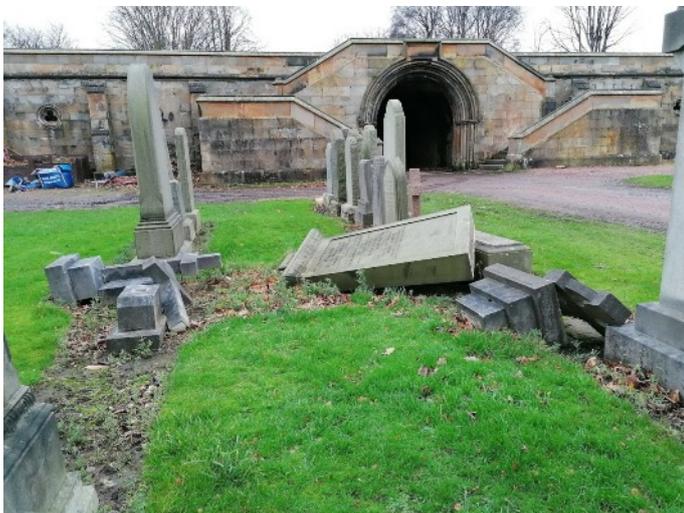
**BEFORE**

*Community Payback Order workers have restored the smaller stones to the left in the photos above, situated just north of the tunnel by the catacombs. The larger stones on the right in the photos are awaiting professional restoration by stonemasons financed by the Grange Association.*

To move stones over six feet high needs heavy lifting equipment and cannot be tackled under the Community Payback Scheme. The Grange Association has agreed to fund a commercial company to re-erect some larger stones. The first four large stones are expected to be done later in 2021. Photos overleaf show the group of stones near the Catacombs, with the small ones completed by Payback workers and the larger ones awaiting professional attention.
